## External Water-Bar Installation – National Starch, Karasin

Whether damaged during installation, incorrectly detailed or omitted all together, the failure of the waterproofing at the main construction joint between two primary waste water treatment tanks caused major problems for National Starch maintenance staff in Karasin.

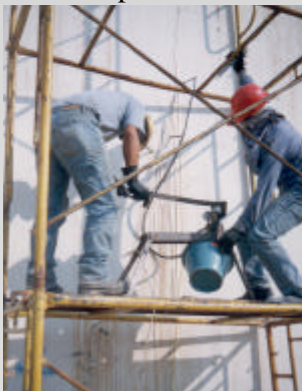
- 1 Failed construction joint
- 2 First pass PU injection
- 3 Forming chase
- 4 Second Pass PU injection
- 5 Installation
- 6 Surface repair

The solution proposed by Hammersmith was the post installation of the Dila Joint Tape System from Messrs. Vandex International
